TECHNICAL NOTE

Project: **East Witney - Cogges Link Road**
Subject: Flood Risk & Drainage Review
Prepared by Zeean Brydon (Associate Director)
Approved by Iain McNeill (Associate Director)

Job No: **WE01386-TN02**
Page 1 of 10
Rev D
11-04-2011

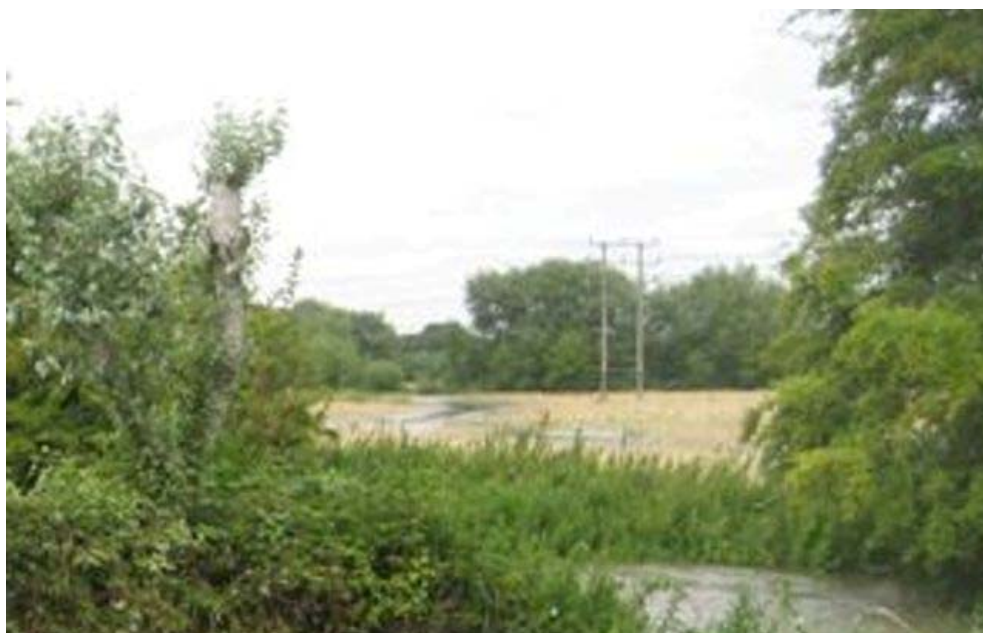
Photograph A Extract Showing Flooding within the Country Park. Flood water can be seen on the footpaths in the park, it is reasonable to assume floodwater extends into the tall grass either side of the footpath.

Photographic Evidence gathered at or near peak flood confirms significant flood flow through the Country Park as a result of overtopping of the River Windrush. Eye Witness accounts confirm that flood waters breaching the banks of the Western Windrush flowed from north to south along the Farm Mill access road and into the Country Park. Eye Witness accounts confirm that flood flows also breached the Eastern Windrush channel contributing to the flood flow along the Farm Mill access road and into the Country Park. (Refer Photographs A, G and E on Drawing WE01386-C-103). Photograph A is enlarged below for clarity. Further photographs can be provided if required.

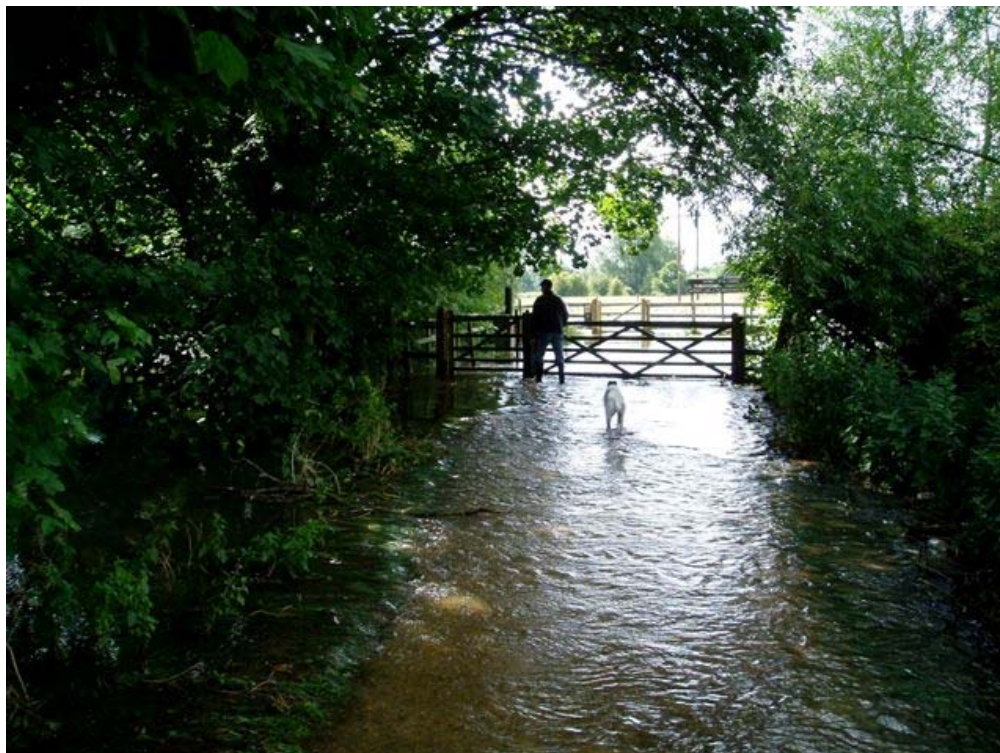
Photograph E – Flood Flows entering the Country Park

Photographic Evidence of the July 2007 flooding (Photographs E and G of Drawing WE01386-C-103) clearly demonstrates that the flood flows were not contained within the river banks and that overtopping could not be described as 'some local overtopping'.

$0.01\text{m}^3/\text{s}$ (10l/s) is approximately equivalent to the flow from five 2litre milk bottles overtopping the eastern channel on Farm Mill Road and flowing through the Country Park every second. Photographs E and G show flood flows which are significantly greater than 10l/s. Photograph E (included below) shows a flood flow approximately 5-6m wide with a depth in the order of 100 to 200mm. The flow rate is estimated to be in the order of 1m/s, giving a flood volume in the order of $0.5\text{m}^3/\text{s}$ to $1.2\text{m}^3/\text{s}$ significantly (50 to 120x) greater than that suggested by Jacobs. The Jacobs 2011 Flood Model and Flood Mapping does not therefore accurately predict the flood flows as experienced on site in July 2007.

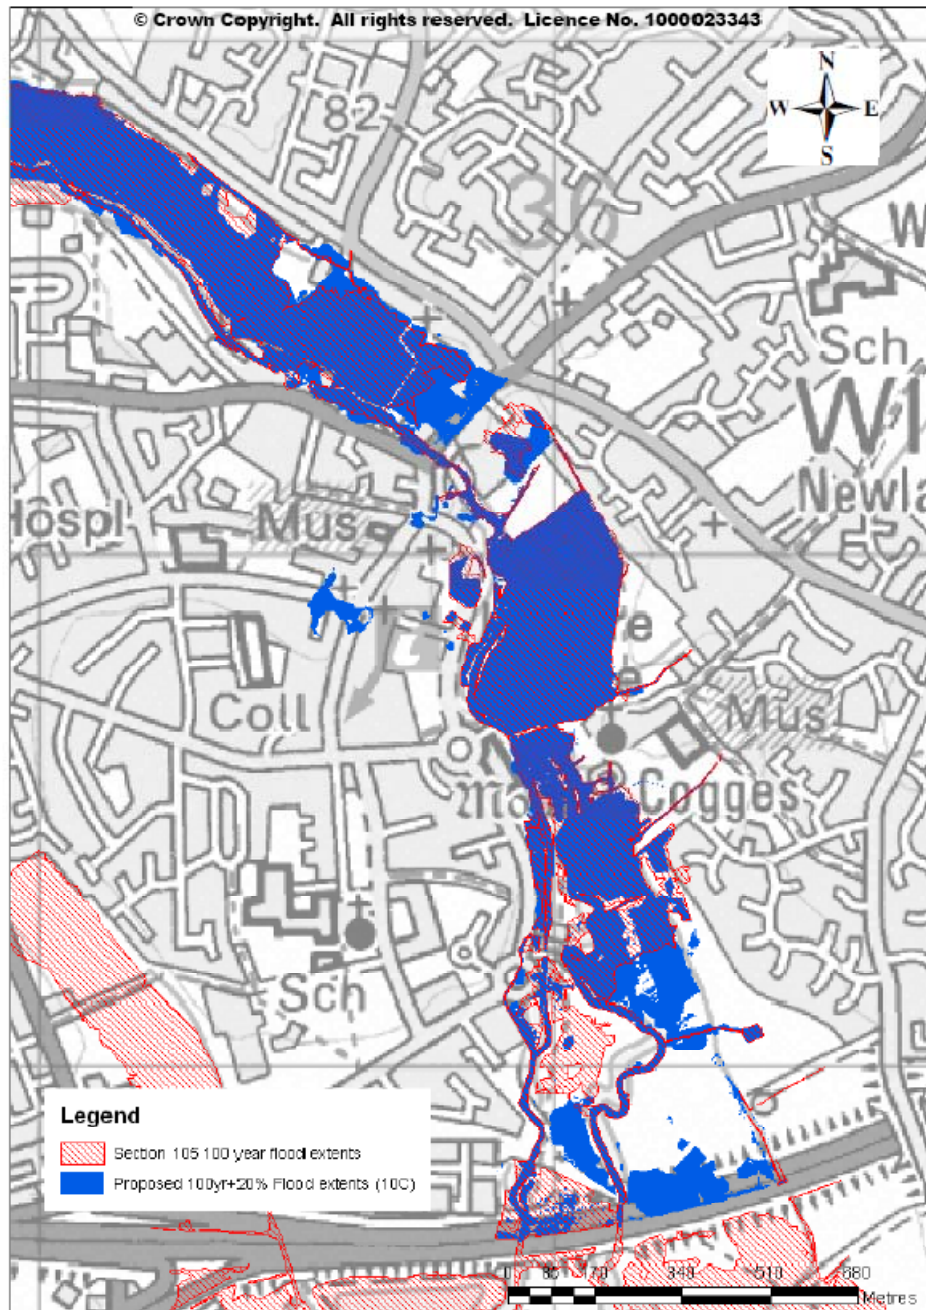
Figure 23 100 Year plus 20% Design Flood Extent

Figure 23 and Section 5.7 of the report compares the proposed 100 year flood extent with the Section 105 flood extent. The report clarifies that this comparison shows "a number of areas where the 100year plus 20% flood extent requires refinement. In particularly the area south east of Bridge Street should be shown to be subject to more general flooding, and flooding along the streets on the opposite side of the river should be clarified".

The report goes on to correctly identify that the S105 outline shows "substantial areas of flood risk in the general vicinity of the CLR" which are not replicated by the Jacobs 2011 calibrated flood model. The reports states that the model shows "small flows taking place over the banks of the various channels into the historic floodplain areas and across the proposed CLR alignment", but confirms that the lack of ponding is a result of "sufficient gradient" across the floodplain.

Figure 23 is attached for clarity.
